Manhole Inspection Summary

Manhole # S35KK_053MH

Insp Date: **3/9/07 1:30 PM**

Location Address: **210 MCALLISTER ST**

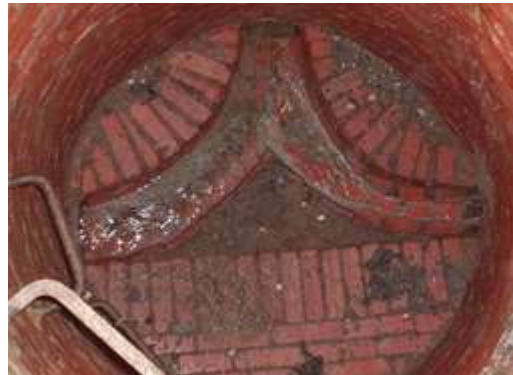
Top View

Bench and Channel debris.

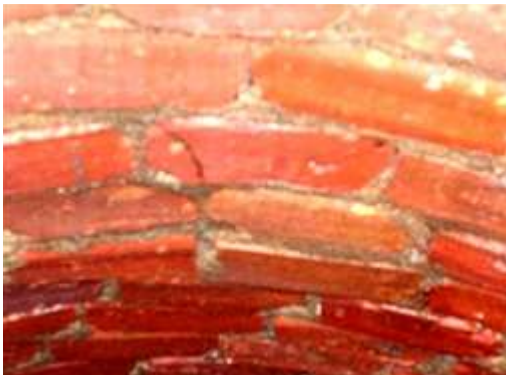
Defect

Cobel infiltration.

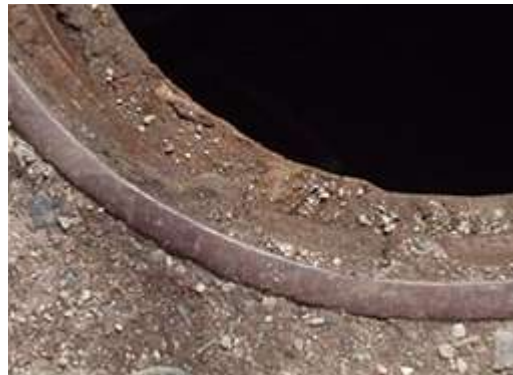
Defect

Offset: **2** (in.)

Infiltration: ☐ None ☒ **Joint** ☐ Cracks ☐ Mortar ☐ Roots ☒ **Wall**

Frame offset. Adjustment infiltration.

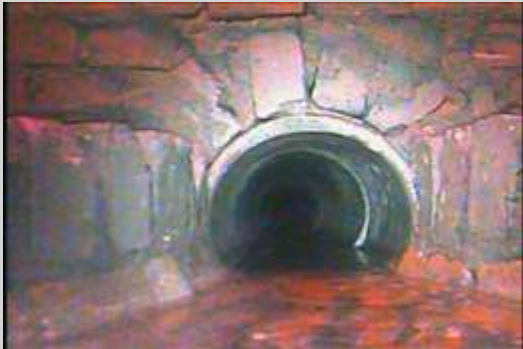
8 in. Circular Gravity Sewer Pipe Out @ 12 O'Clock

Barrel deterioration and infiltration.

Infiltration: **Evidence** Pipe Seal Cond: **Cracked**

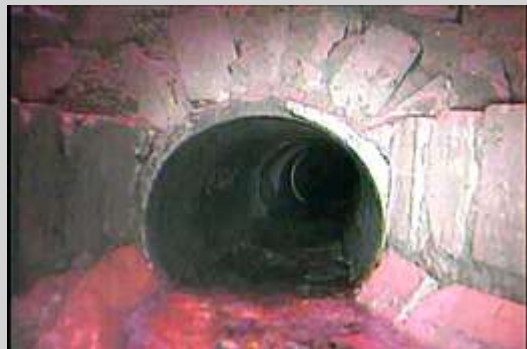
Pipe In @ 9 O'Clock

Infiltration: **Evidence**

Pipe Seal Cond: **Broken**
